Suspect Asbestos Containing Building Materials Survey

**Valley Crossing Storage Structure
Whitmore Park
Morgantown, WV 26505**

Cira and Associates Consulting LLC
468 Williams Road
Morgantown, WV 26501
C&A Project No. CAC23218

November 17, 2023

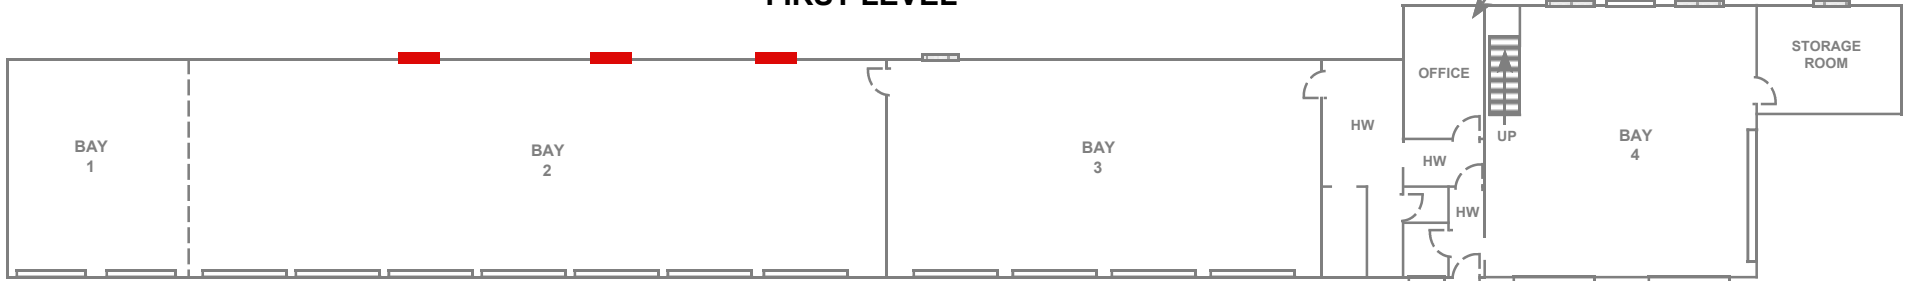
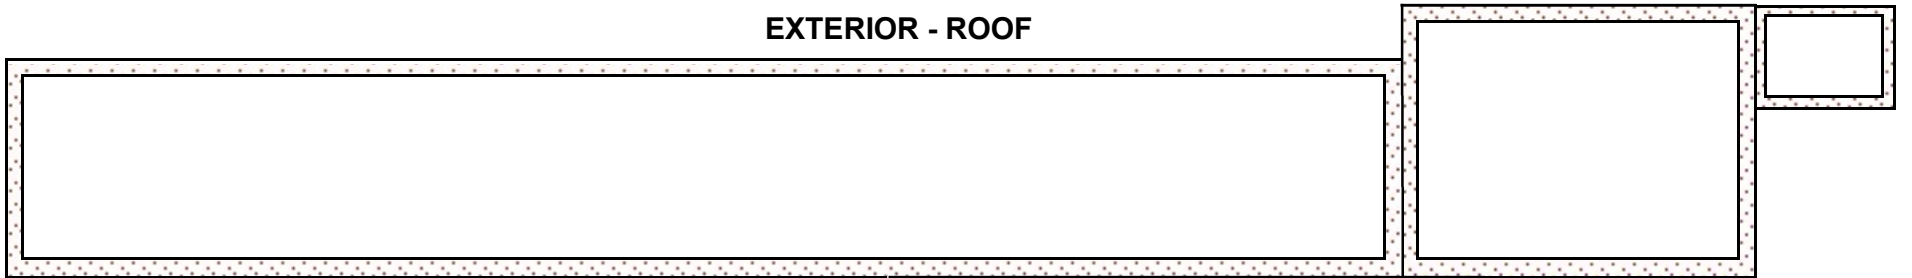
Figure 2

- Approximately 1,400 ft.² of ACM black flashing on the parapet wall around the perimeter of the flat roof on the structure.
- Approximately 24 linear feet of ACM light tan window glazing located on three rear windows in bay 2 area.

ACM Rear Window Glazing

ACM Black Roof Flashing

ACM Locations
Valley Crossing Storage Structure
Whitmore Park
Morgantown, WV

As required by West Virginia Division of Health Legislative Rules Title 64 Series 63 (1998), C&A recommends the confirmed ACMs be removed from the above detailed location prior to conducting any demolition or renovation activities that may disturb the material. West Virginia State Law requires asbestos removal to be performed by personnel trained and licensed in asbestos abatement activities. Abatement must be performed in accordance of the West Virginia Division of Health Legislative Rules Title 64 Series 63, OSHA Asbestos Construction Standard 29 CFR 1926.1101 and the EPA Asbestos NESHAP guidelines 40 CFR 61, Subpart M.

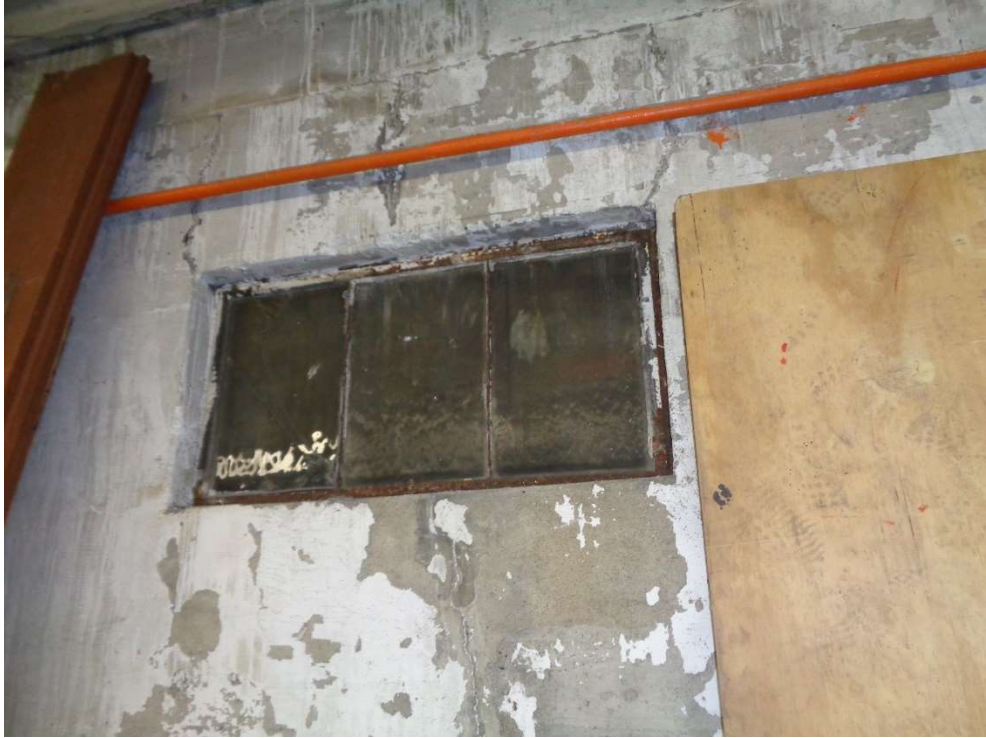
Material Description	Material Location	Estimated Quantity	Condition	C&A Sample Number
Rear Window Glazing	Bay 2 (3 Windows)	24 LF	Poor	CAC23218-01 CAC23218-02
Roof Flashing	Parapet Wall on Original Roof	1,400 SF	Fair to Poor	CAC23218-11 CAC23218-12

Photo of the ACM window glazing located on the rear window of bay 2 area.
(CAC23218-01)

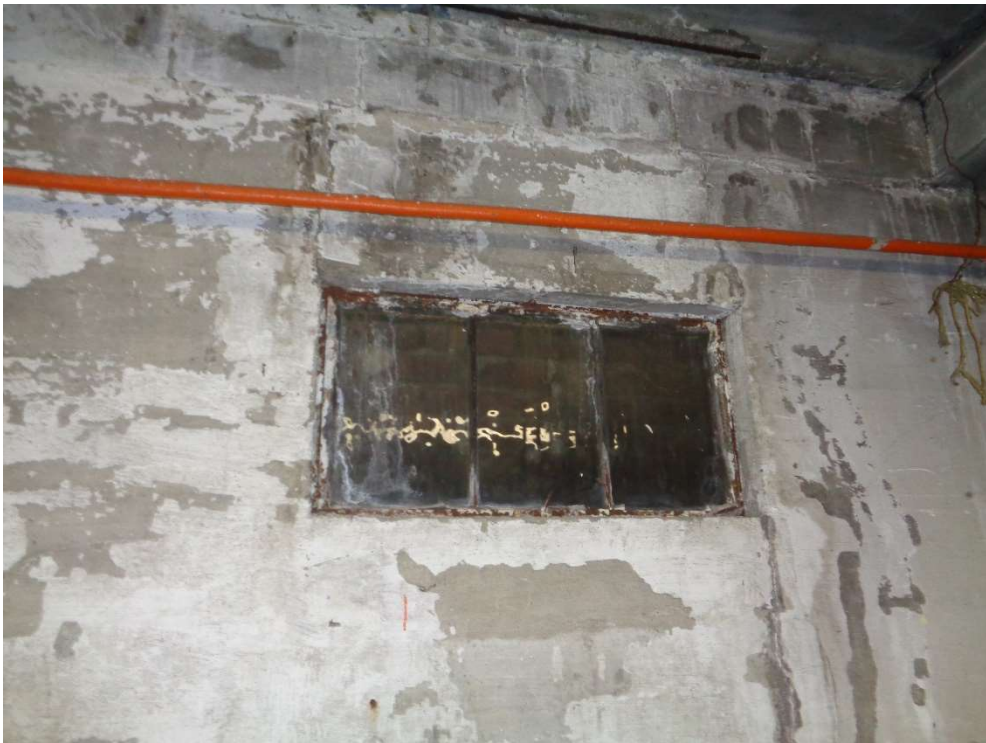
Photo of the ACM window glazing located on the rear window of bay 2 area.
(CAC23218-02)

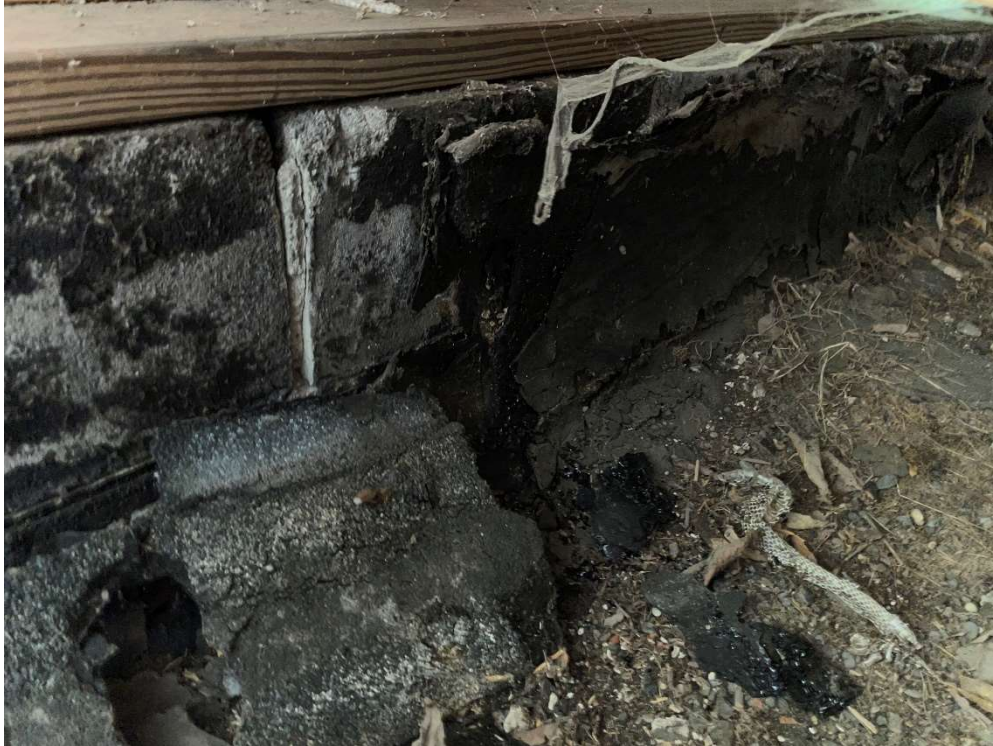
Photo of the ACM black flashing on the parapet wall of the original roof located under the metal roof. (CAC23218-11)
